RENOVATE AND EXPAND CHAMCHAMAL CORRECTIONAL FACILITY CHAMCHAMAL, IRAQ SUSTAINMENT ASSESSMENT

SIGIR PA-09-177 OCTOBER 22, 2009

SUBJECT: Report on the Sustainment Assessment of the Renovation and Expansion of the Chamchamal Correctional Facility, Chamchamal, Iraq (SIGIR Report Number PA-09-177)

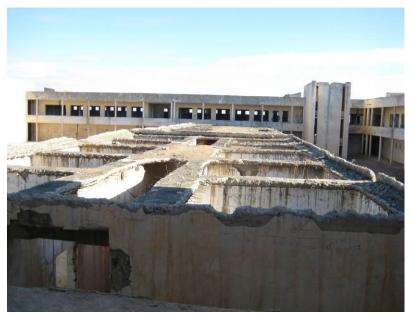
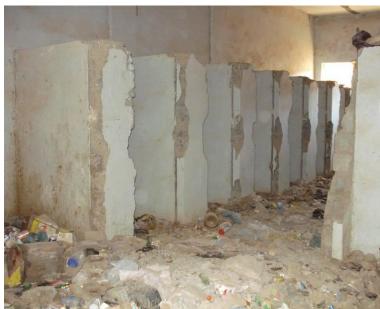
Site Photos 1 and 2. Condition of the Chamchamal Correctional Facility prior to renovation and construction (Photos courtesy of the USACE)

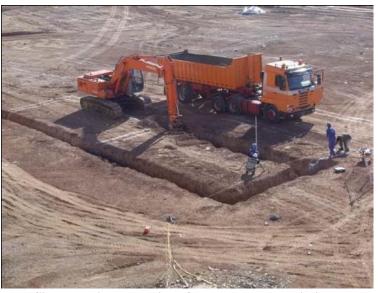
Site Photo 3. Excavation of guard barracks building (Courtesy of USACE)

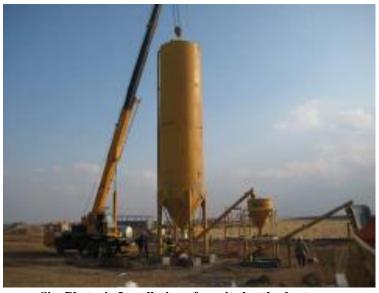
Site Photo 4. Installation of on-site batch plant (Courtesy of USACE)

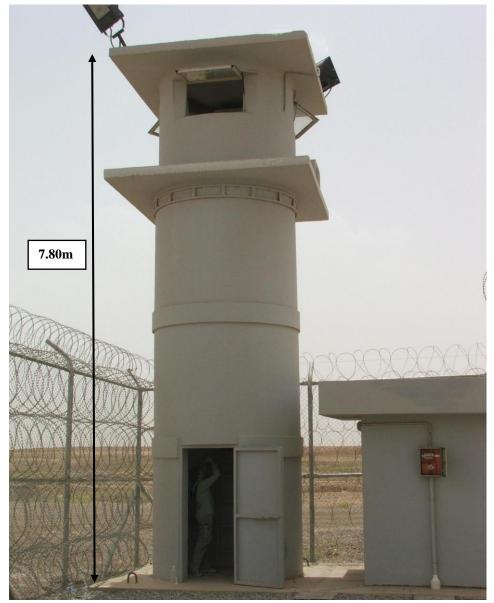
SIGIR inspected the guard tower near the facility's entry control point. The tower is approximately 7.8 meters tall with two exterior lights (Site Photo 7). SIGIR climbed the stairs to the top of the guard tower and confirmed that the four lookout windows provided 360-degree coverage of the surrounding area. The lookout window provided an

Site Photo 7. Guard tower, which provides 360-degree coverage of surrounding areas

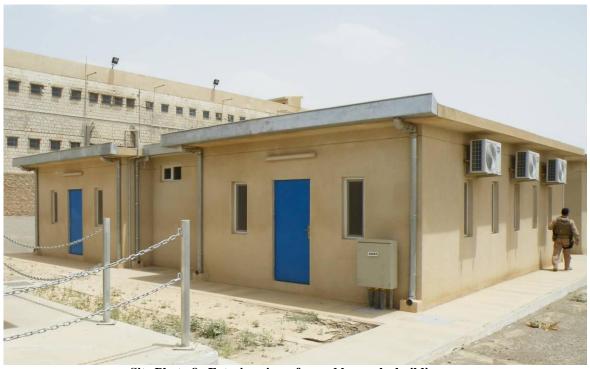
SIGIR inspected one Type A and one Type B guard barracks (Site Photo 8). The Type A guard barracks building comprised a bathroom with three toilets, sinks, and showers; six ceiling fans; and eight heating, ventilation, and air-conditioning (HVAC) units. The Type A guard barracks building appeared to be adequately constructed. SIGIR observed a sufficient number of lighting fixtures, electrical outlets, and windows to allow the guards to read at desk-top level. Also, the combination of ceiling fans and HVAC units should be adequate to maintain a cool temperature during the hot summer months.

Site Photo 8. Exterior view of guard barracks building

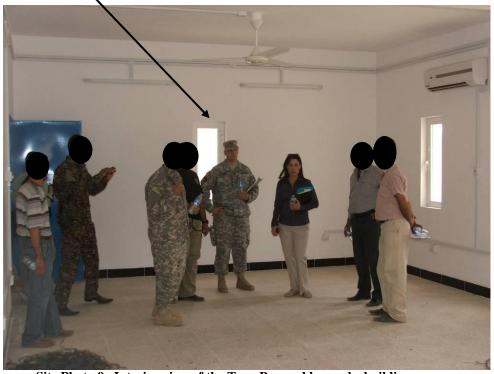
The Type B guard barracks building appeared to be adequately constructed. SIGIR observed a sufficient number of lighting fixtures, electrical outlets, and windows to allow the guards to read at desk-top level, and the combination of ceiling fans and HVAC units should be adequate to maintain a cool temperature during the hot summer months (Site Photo 9).

Site Photo 9. Interior view of the Type B guard barracks building room

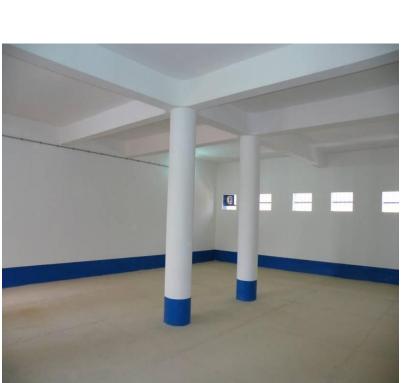
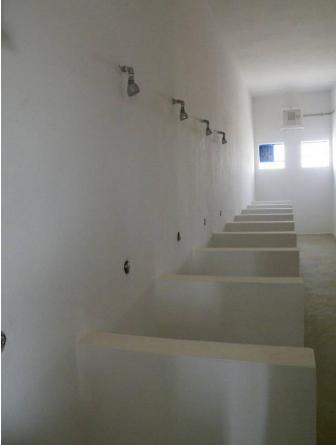
SIGIR entered the open-bay housing area and bathroom for one dormitory-style housing unit. SIGIR found the unit adequately constructed with the appropriate number of sinks, toilets, and showers as prescribed by the SOW (Site Photos 11 and 12).

Site Photos 11 and 12. Interior views of the open dormitory-style housing units

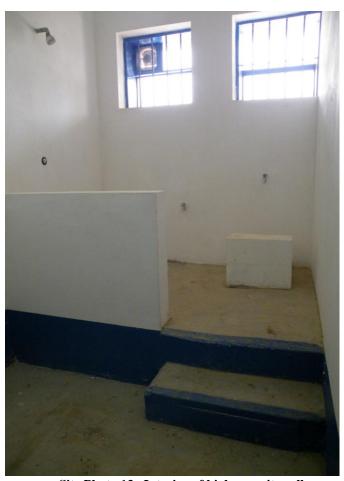
SIGIR entered one single-bed, one two-bed, and one four-bed cell. SIGIR found the cells adequately constructed. Each cell had one sink, toilet, and shower (Site Photo 13). In addition, each cell had one wall-mounted HVAC unit, one exhaust fan, and wall-mounted lighting. The contractor took the extra security precaution of enclosing in a cage the HVAC unit, light, and electrical wiring to prevent prisoners from tampering with the equipment or use it as a weapon (Site Photo 14). Also, the SOW required that all openings within the dormitory housing units larger than 15 x 15cm must have security bars, and the bars must be placed on the inmate side with operable windows and handles positioned on the corridor side. All windows have glass that is tempered and wire-reinforced for added security (Site Photo 15).

Site Photo 13. Interior of high-security cell

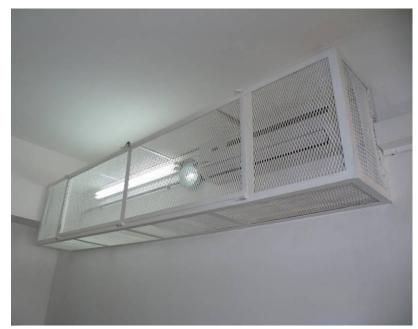
Site Photo 14. Metal cage protects the HVAC, light, and electrical wiring

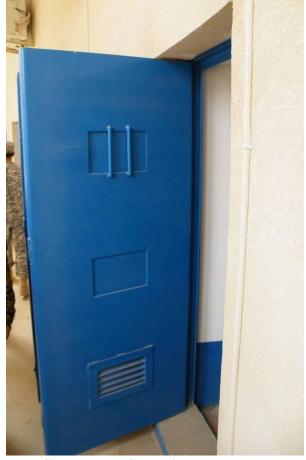
All electrical panels, switches, and outlets are located outside of the dormitory, and the electrical panels are in a separate closet. Each prison cell door was made of steel, swung out into the hallway, and had lockable food slots (Site Photo 16).

Site Photo 16. Steel prison cell door

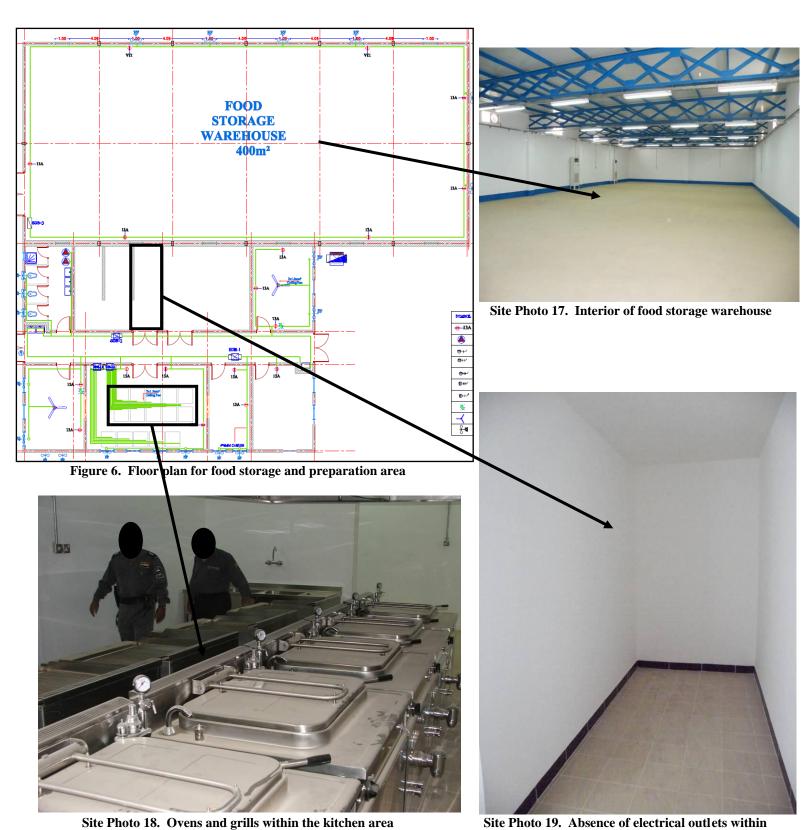
SIGIR visited the food storage and preparation areas and found the rooms adequately constructed. The food storage warehouse is a large, open room with plenty of capacity to store non-perishable food (Site Photo 17). The kitchen was furnished with the SOW-required five ovens, five grills, five steam kettles, exhaust hoods, and a stainless steel sink (Site Photo 18). However, SIGIR noted that the refrigeration room did not contain any electrical outlets (Figure 6 and Site Photo 19). The provisional warden expressed concern that the absence of electrical outlets will nullify the intent of the refrigeration room. The warden stated that perishable food will have to be stored somewhere else, or long extension cords will need to be run from another room into this room. The warden is concerned that the high foot-traffic in this area increases the potential for the extension cords being unplugged or cut, which could lead to either spoiled food and/or a potential fire.

Site Photo 19. Absence of electrical outlets within the refrigeration room

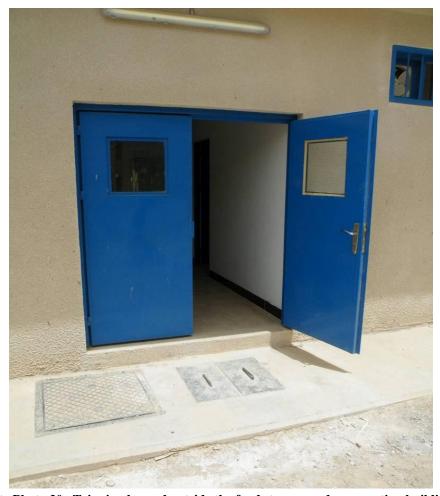
Finally, when exiting the food storage and preparation building, SIGIR noticed a metal handle for a subsurface utilities access panel, which posed a significant tripping hazard for prisoners and guards (Site Photo 20).

Site Photo 20. Tripping hazard outside the food storage and preparation building

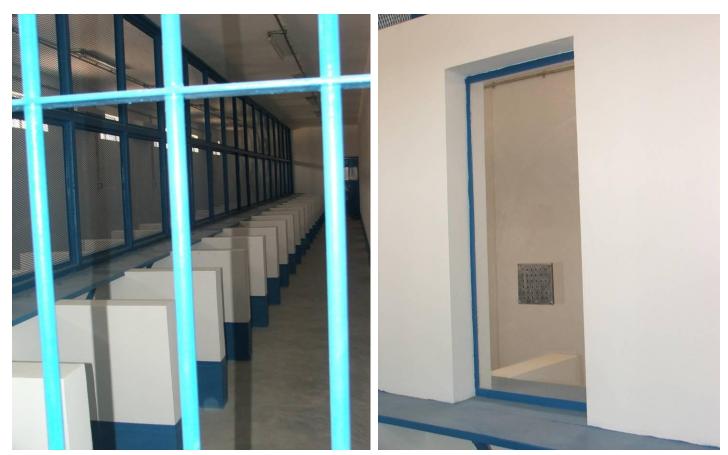
SIGIR inspected both visitation areas and found that each was adequately constructed. The general population visitation area is constructed to allow a maximum of 36 inmates to receive visitors at a time; the high-security visitation area allows a maximum of 10 inmates to receive visitors at a time. The general population visitor counter had a security-fence divider with wire-mesh openings, which were continuous and secured to the ceiling with no gaps (Site Photo 21). The significantly smaller, isolated high-security visiting center completely separated visitors and inmates, using plexiglass with a speaker plate (Site Photo 22). The general population security-fence divider and the high-security plexiglass with speaker plate were well constructed and do not present an opportunity for a visitor to pass contraband to a prisoner. An observation point allows guards to monitor the entire visitation area secured from the inmates. The general population and high-security visitation areas are constructed of masonry and concrete with a gypsum interior finish and an exposed finished concrete floor.

Site Photos 21 and 22. Examples of dividers between visitors and general-population prisoners (left) and high-security prisoners (right)

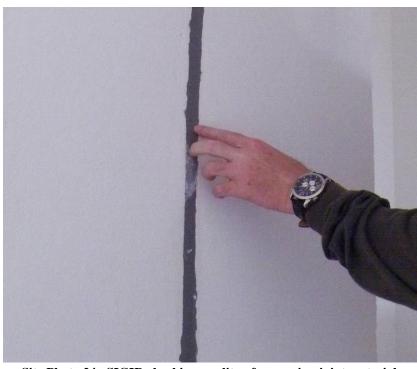
Site Photo 24. SIGIR checking quality of expansion joint material
